New Jersey Pollutant Discharge Elimination System (NJPDES) Permit No. NJ0165808 Compliance Sampling Inspection conducted on October 16, 2018

NJPDES Compliance Sampling Inspection (CSI) Report: Sediment

Bayonne Dry Dock & Repair Corp.

Inspection Date: October 16, 2018

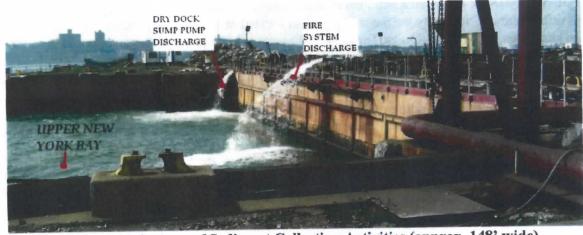
Photo #1: Main Area of Sediment Collection Activities (approx. 148' wide)

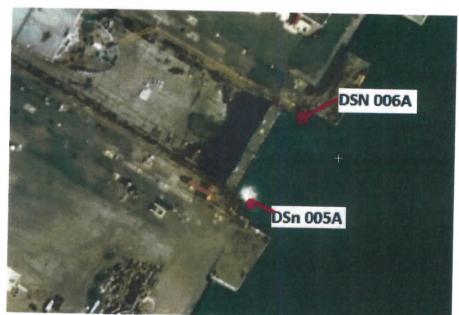
Photo #2: Permitted Sediment Sampling Locations - Provided by NJDEP

Sediment samples were collected by EPA Region 2/ERT Dive Team outside of the caisson door at the two permitted sample points shown in Photo #2.

The exact locations should be determined and agreed upon with NJDEP and appropriately marked for easy identification. Refer also to Photo #2 provided by the NJDEP.

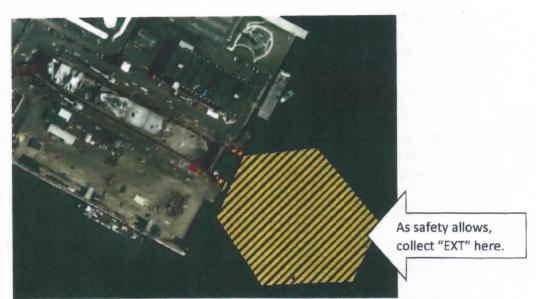
- The sediment drift sample (DFT) was collected along the southeastern edge of the bulkhead of the floating dock.
- A background sample (EXT) was collected further out from the caisson door in the area shown in Photo #3 (below).

Photo #3: NJDEP Suggested Area for Collection of Background Sample ("EXT")

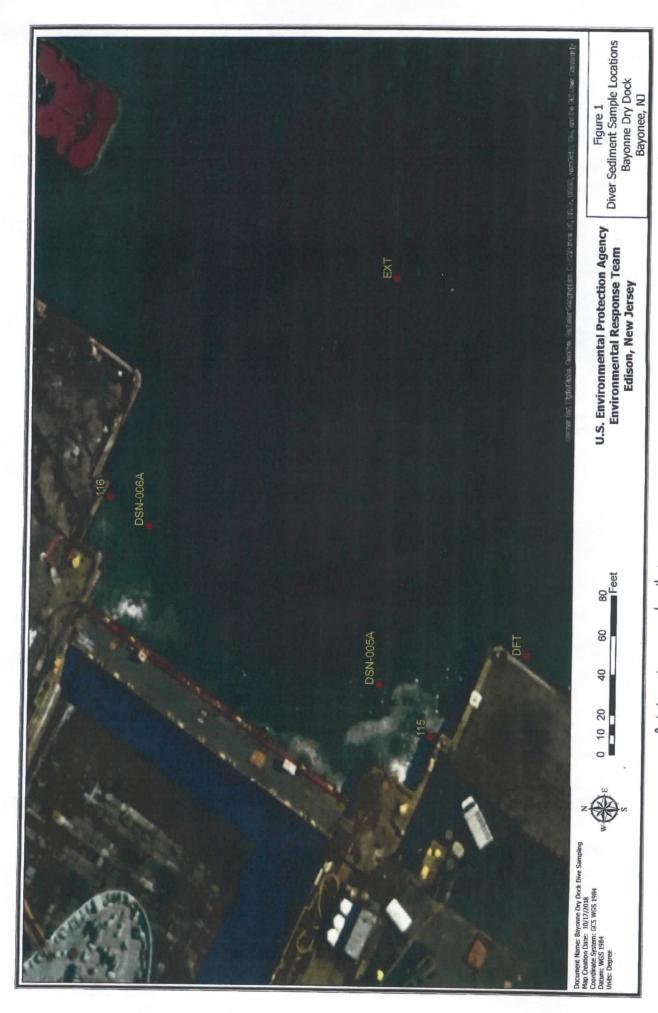
Attachment #1: BDD Sediment Sampling Points

The EPA representatives did not disembark onto BDD property, aside from tending to the dock lines, so no true inspection occurred. There was a discrepancy on the exact locations for monitoring DSN 005A and 006A among facility representatives and the EPA. There was some discrepancy with the locations described by the facility representatives. It was determined that the locations for 005A and 006A are as described on page 5 of this report, i.e., 40 feet off the caisson door (East) and 25' vs 50' off the bulkhead. Questions on which bulkhead this distance was to be measure from resulted from the non-uniform bulkhead (segmented).

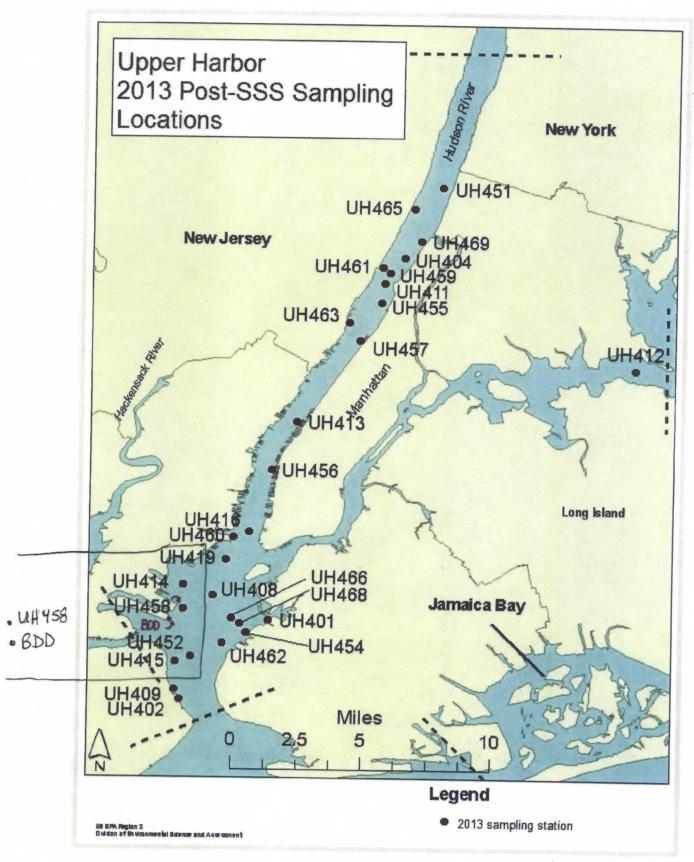
Attachment #4: REMAP Sample Sites
